Standard Building Inspection Report

For Larry Davis of 234 Baymeadows Way, Jacksonville, FL

Report: TG51103 (5/25/2004 - 1643 Kingfisher Lane)

Property Address: 1643 Kingfisher Lane
City, State, Zip: Ponte Vedra Beach, Fl. 32082
Property Type:
Occupied: Yes
Utilities On: Yes

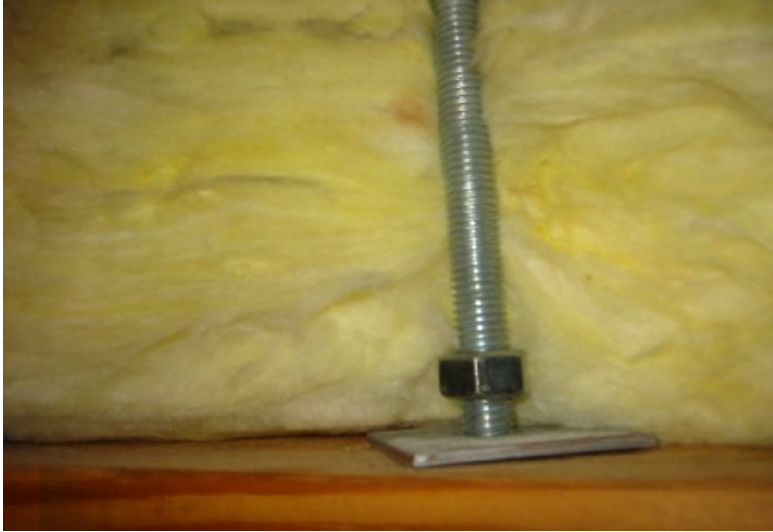
141_Loose anchor bolts in attic

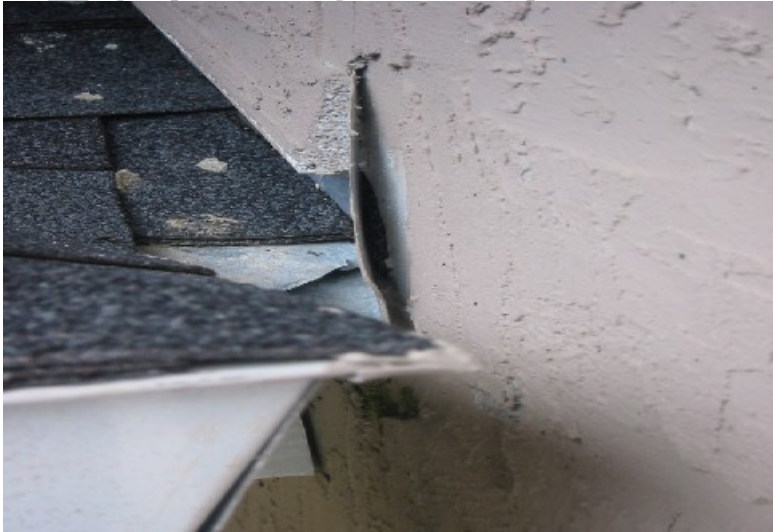
Exposed expanded lath at roof wall intersection left side of front door. Moisture stains noted. Vulnerable detail for future moisture related issues. Recommend upgrade of rain run off and sealants. Additional evaluation/repairs needed.

210_Flashing

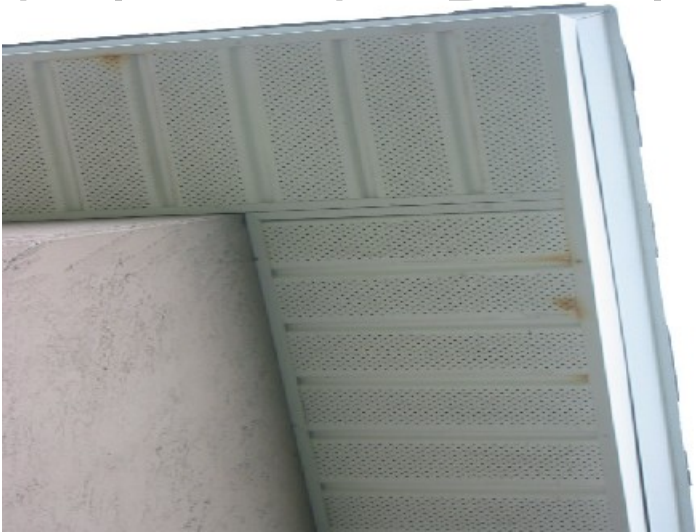
External fasteners prematurely deteriorated (rusting). Non corrosive fasteners should have been used.

221_Rusty nails

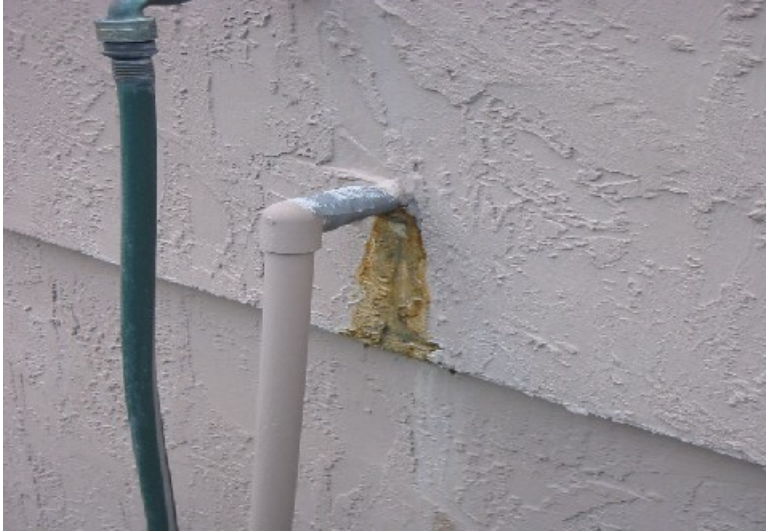
Noted at HVAC condensate line to right side. Moisture stains present. Unable to determine inner wall or stucco deterioration without invasive testing. Probability low. Evaluation / repairs needed.

223_Moisture stains

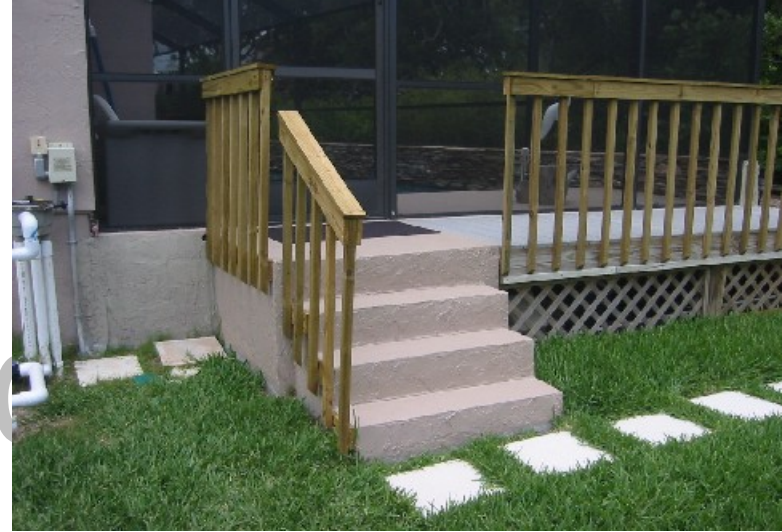
Porch railing is loose. Hand rail loose/missing. Non standard deck construction. Ballustrading incorrect. Upgrade needed / Safety hazard.

233_Loose rails

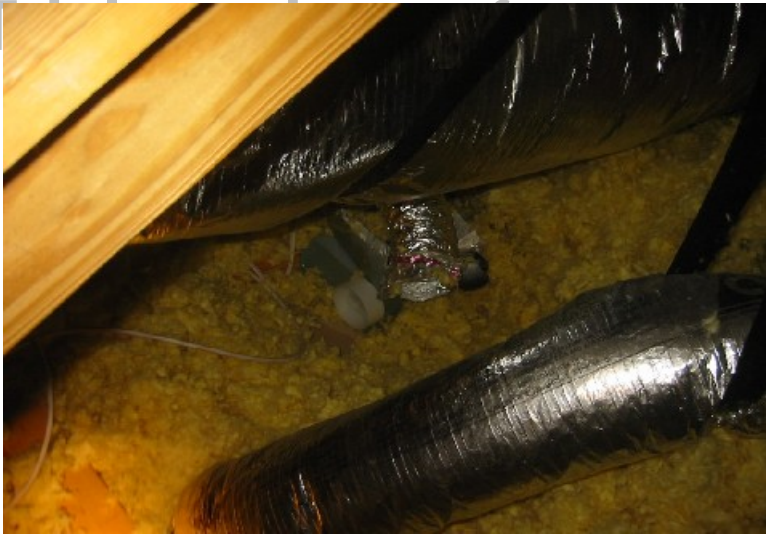
Duct disconnected in attic.

428_Duct disconnected in attic

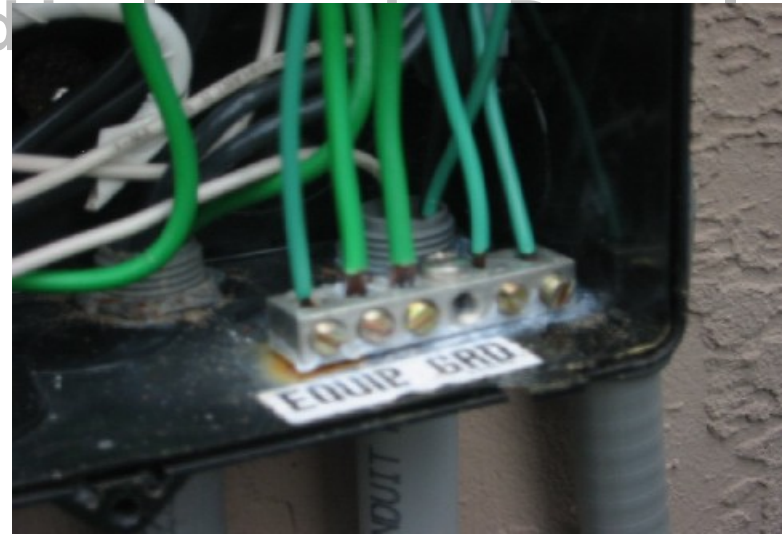
Slight oxidation/rust noted at pool sub panel cover. Not typical for age of system.

Premature deterioration. Check/repair needed.

509_Slight oxidation and rust noted at pool sub panel cover

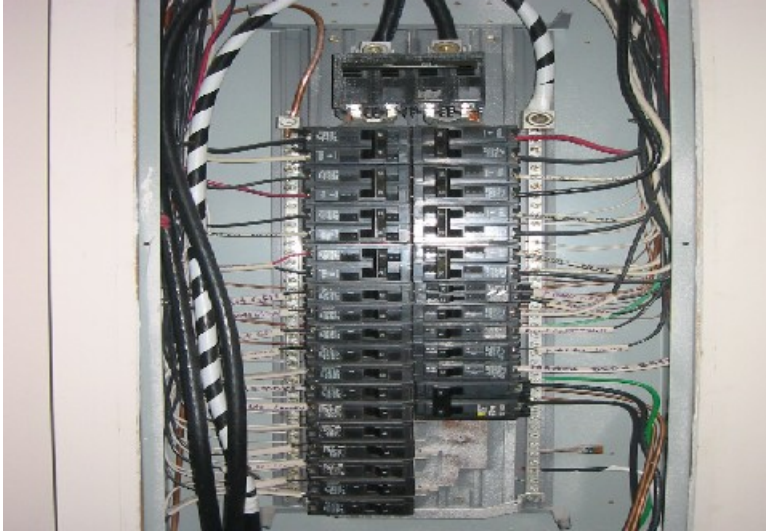
Paint over spray from construction noted inside panel phase conductors and connections. Not permitted per manufacturer's instructions and typical industry standards.

515_Paint over spray

523. Licensed Electrical Inspection Advised

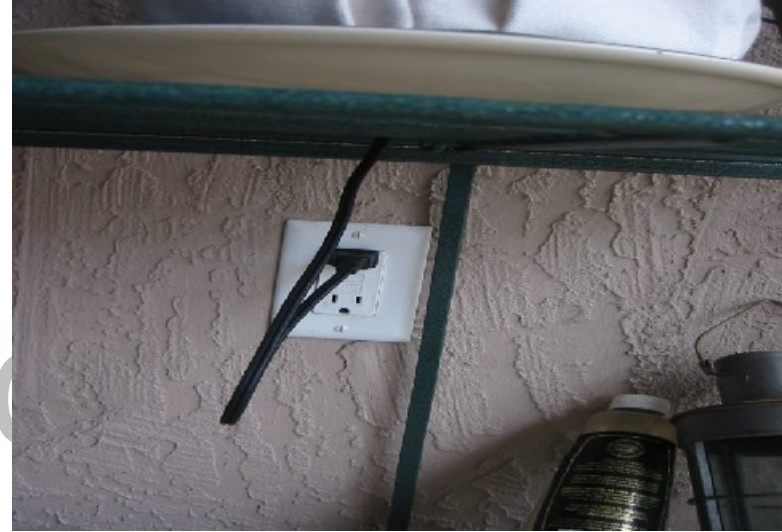
Rear porch receptacle not exterior rated. Replace.

536_Rear porch receptacle not exterior rated

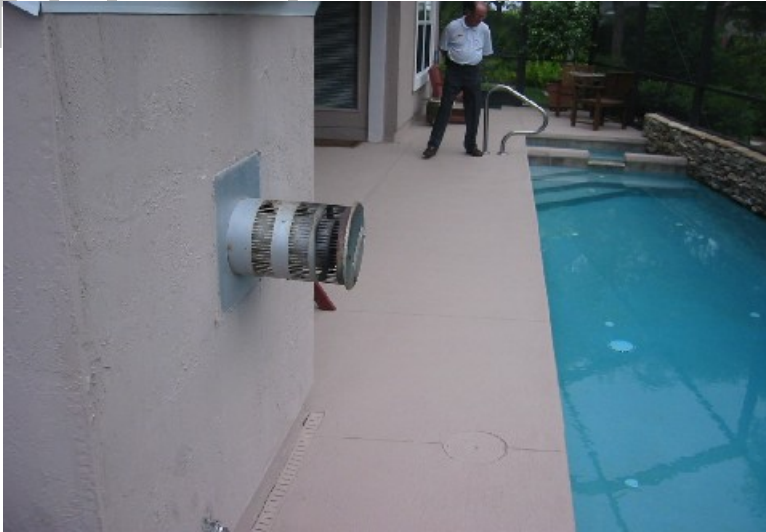
Direct vent flue extends too close to pool edge. Not permitted. Safety hazard. Rust noted also.

612_Direct vent flue extends too close to pool edge

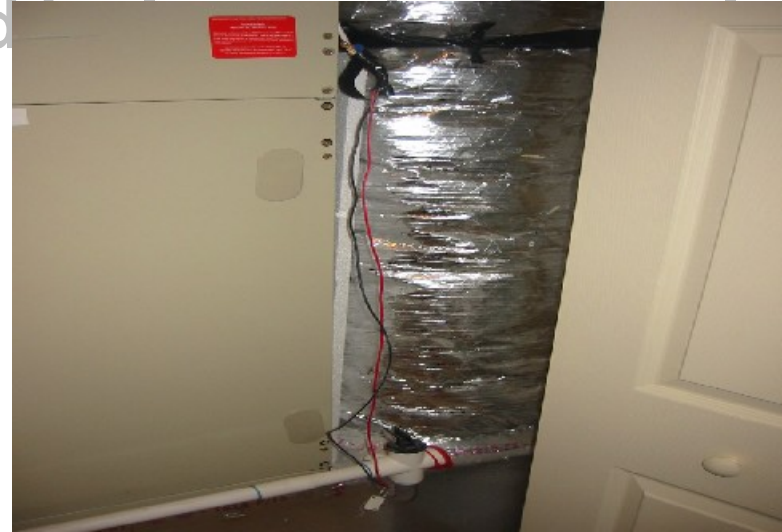
625_Disconnected condensation float

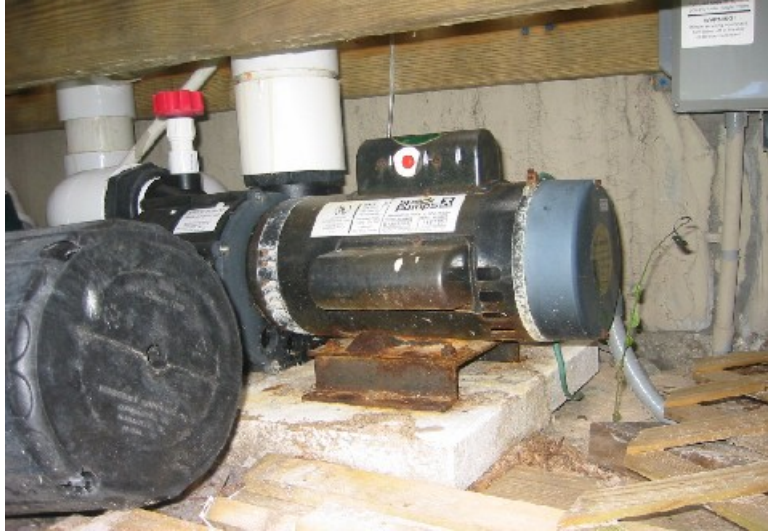
Swimming jet pump under deck not accessible. Not properly secured. Leakage and corrosion also present. Unable to operate at time of inspection. Electrical bonding not identified. Repairs needed. Confirm operation with owner prior to closing

737_Swimming jet pump under deck

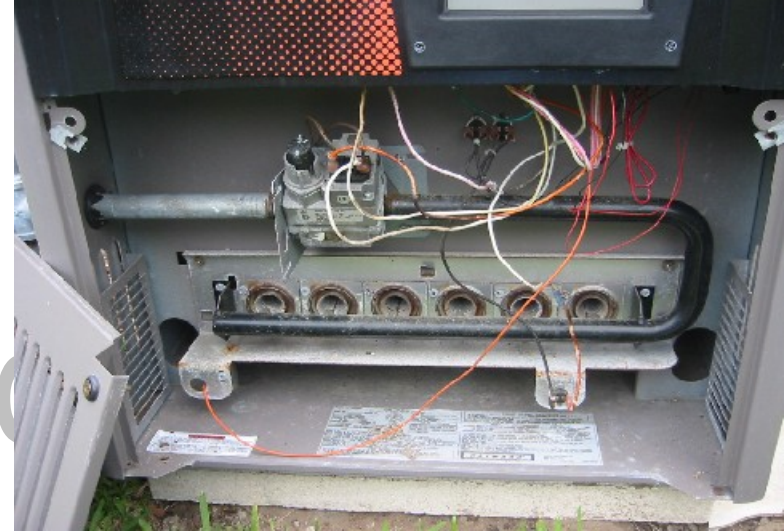
Not protected from surface water rain run off. Recommend gutter protection. Unit too close to house and not properly secured and supported on a concrete slab. No manufacturer,s documents present to check clearance. Typical clearances not present. Exhaust flue also below soffit vents. Check manufacturers specifications. Budget possible upgrade. Service / clean needed. Review by pool specialist advised. See also comments on direct vent flue clearances with pool noted in section 6.0.

738_Pool Heater Chamber

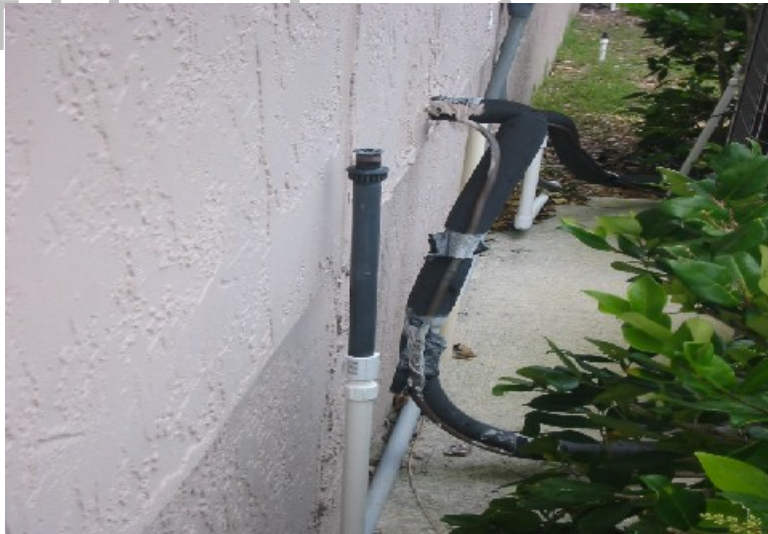
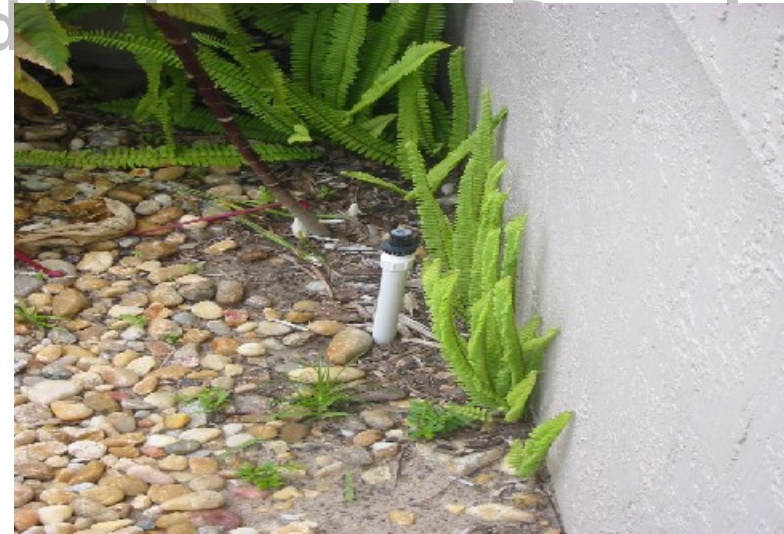
Sprinklers installed too close to exterior walls. Industry standards require minimum clearance of 18 inches. Current condition will promote moisture intrusion and/or other related issues as home ages. Adjust to correct clearance and maintain.

739_Sprinklers installed too close to exterior walls 2

739_Sprinklers installed too close to exterior walls

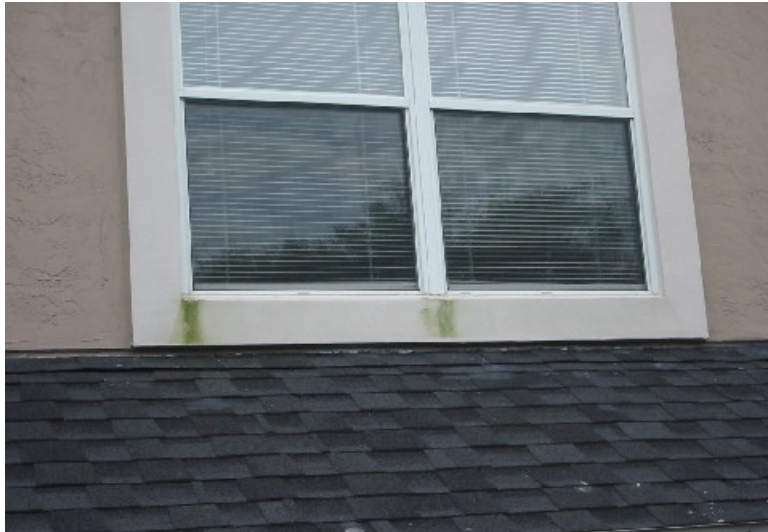
Moisture stains and leakage noted to rear bonus window sill inside and outside. Small area of mold noted to bottom of sill also. Slight separation noted to exterior sill. No active moisture reading at time of inspection. Check historical data with seller. Limited rainfall will

affect accuracy of moisture testing. Check proper window / sealant installation by window specialist/manufacturer.

836_Moisture stains
